**High Level Internal Review
into State of the PWC
Networks, Manning Levels,
Training and Maintenance
Requirements**

Stephen Blanch – Dellwind Pty Ltd December 2006

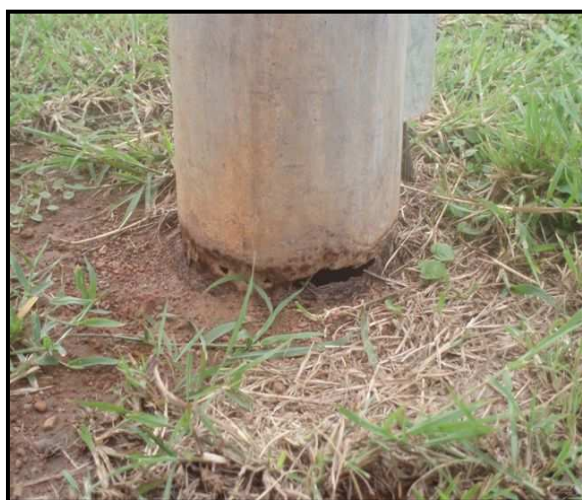
The pole shown in Figure 51 demonstrates that even with steel poles some formal routine inspection program is a necessity as there is an exposure to rust due to the acidity of the soils and the high moisture levels in the wet season. This type of inspection is often carried out as part of the vegetation inspection, which is done regularly in PWC, but it is not clear that any inspections are actually carried out on line assets as part of the vegetation management program.

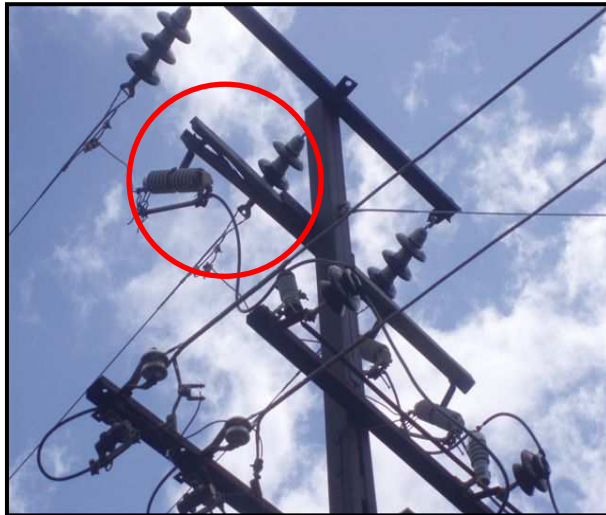
It takes a lot of experience to identify poor cross-arms from ground inspections, and it will be important for PWC to retain skilled line inspectors to ensure that the failure rate trend does not increase. There is no direct data collected on in-service cross arm failures at PWC, as they are included in category A (Equipment failure or Defect), it would be a useful indicator and it is recommended that this data should be collected and analysed in the future.
