**High Level Internal Review
into State of the PWC
Networks, Manning Levels,
Training and Maintenance
Requirements**

Stephen Blanch – Dellwind Pty Ltd December 2006

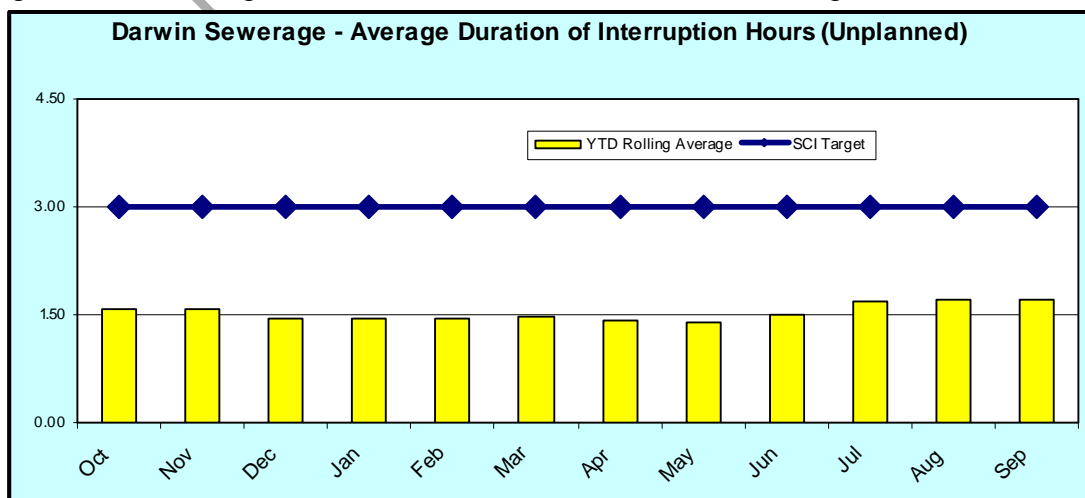
Figure 33: Darwin Sewerage Average duration of Interruption

The average duration of interruption shown in Figure 33 is a creditable 1.5 hours against and SCI target of 3 hours, which is also the WSAA average.

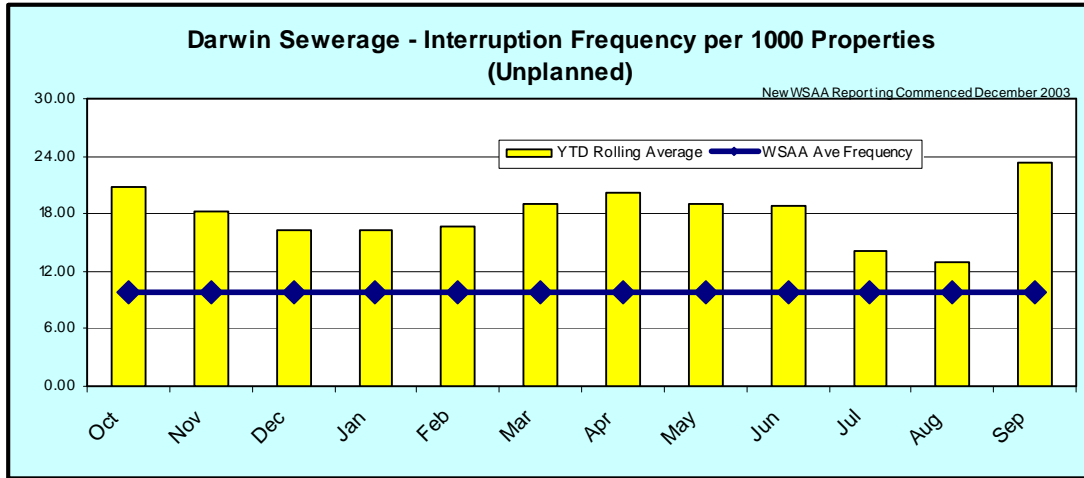
Figure 34: Darwin Sewerage Interruption Frequency per 1000 customers

Again the interruption frequency as shown in Figure 34 is well above the industry average, and is a further indication of deteriorated assets.

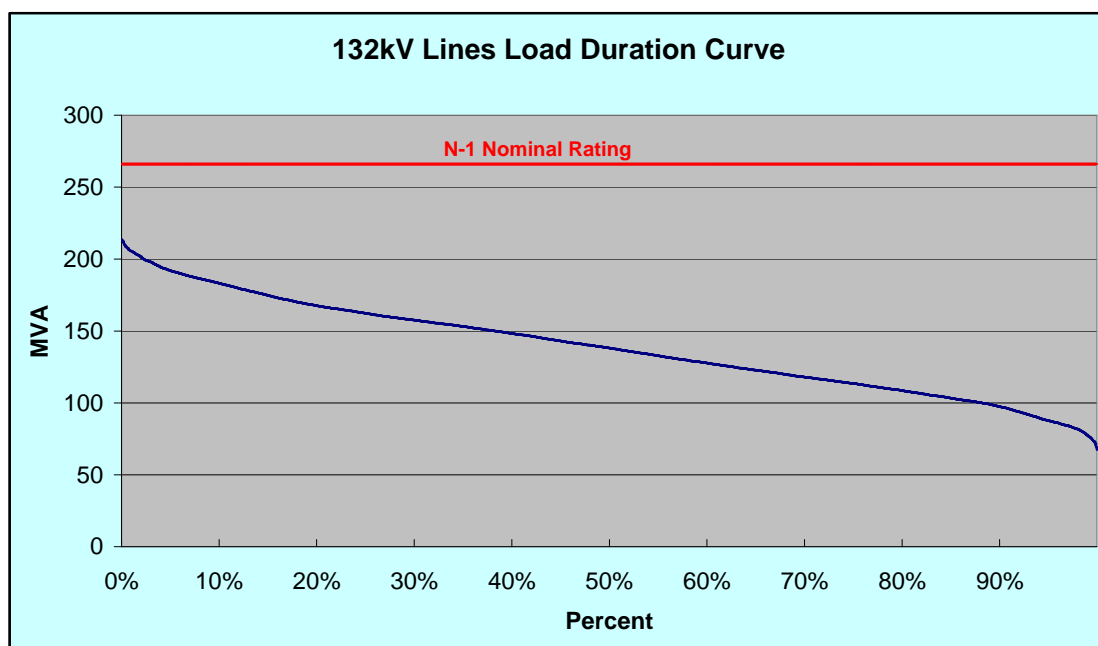
Figure 44: Critical Transmission Lines Load Duration Curve

There is sufficient spare capacity to meet N-1 reliability conditions as shown in Figure 44. Given that the ratings are on a nominal basis, and it is possible to run transmission lines at an emergency cyclic rating of up to 20% above nominal rating there is sufficient spare capacity to meet load growth needs for at least the next 5-10 years given the current long term load growth trend. It should be noted that transmission lines require a very long lead-time, particularly if new easements are required.

There is at least a slight risk of a double contingency event causing severe limitations to supply to Darwin if both circuits were to be taken out of service. Such an event could occur due to severe storm or bushfire because both circuits share the same easement. Future transmission development should consider an alternative easement to Hudson Creek.

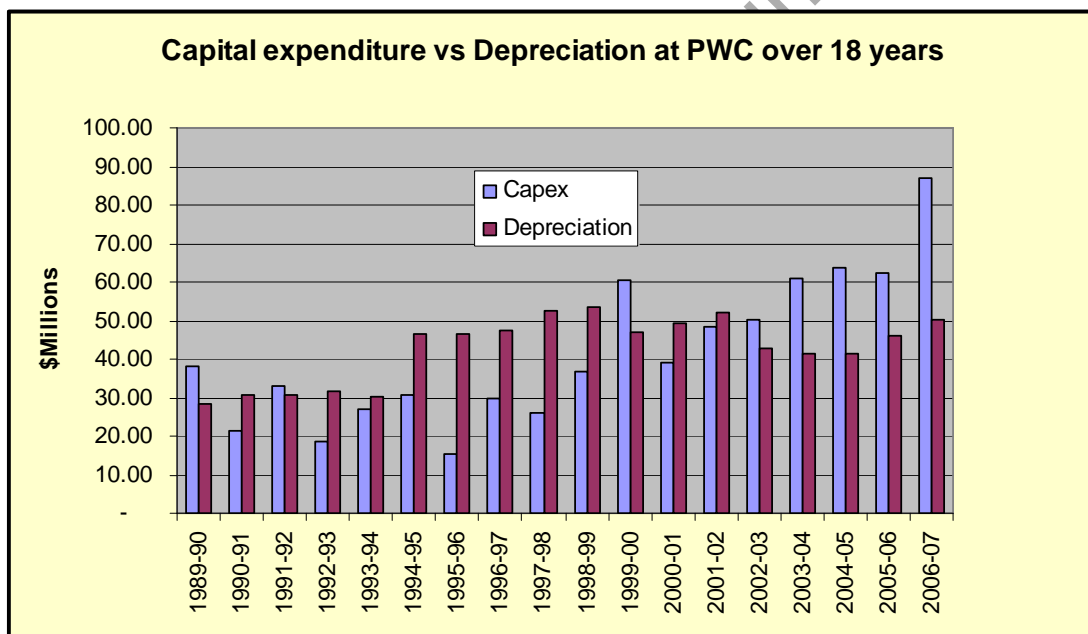
Figure 48: Capital Expenditure and Depreciation & Amortisation at PWC past 18 years

Past capital expenditure at PWC and its predecessor organisation is shown in Figure 48. It illustrates a general underspend of capital. It is most unusual for a utility with assets of the age profile as those in PWC to not be spending at least the equivalent of the asset depreciation on refurbishment or replacement. Given that there has been load growth of around 3% annually over the past many years it would be expected that new assets would also require significant capital expenditure. Even if government or customer contributions initially paid for a number of the assets there is always some component of head works augmentation to meet customer load growth, and that requires new capital over and above depreciation levels of expenditure.

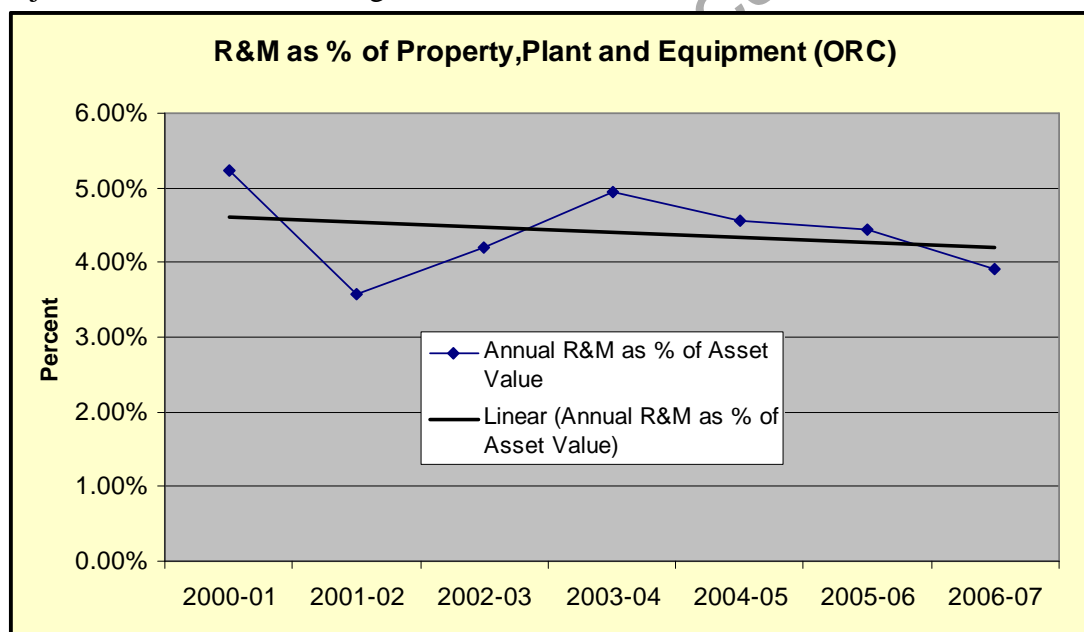
Figure 50: Annual spend on R&M as a percent of ORC (Optimised Replacement Value)

Interviews with staff and a review of the performance indicators show that maintenance is not being carried out in accordance with the processes outlined in the Asset Management Plan at this time. During the extensive interview process it was generally stated that the maintenance approach applied in almost all of PWC's business units is to use reactive maintenance i.e. "When it breaks fix it". While there are some assets in the system where this approach is appropriate, it is not good industry practice to rely on this approach across the broad band of assets to which it applies in PWC. Further the "fix it if it breaks" approach is not in line with the stated objectives in the Asset Management Plans of the various business units.

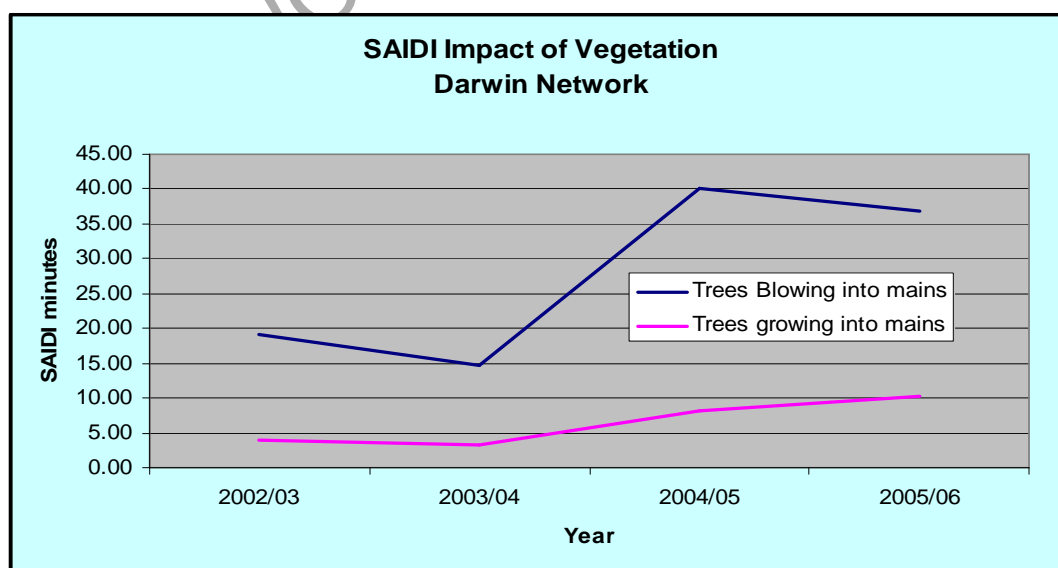
Figure 53: SAIDI Impact of vegetation in Darwin network

Figure 53 shows the impact of vegetation related outages in the Darwin network. The Katherine and Alice Springs networks exhibit a lower impact from vegetation, which should be expected due to the terrain. Quite a lot of the outages caused by vegetation in the Darwin network are not readily preventable even with good vegetation management because of the strong winds and large numbers of palm trees. Despite this a lot of improvement can be obtained with a combination of tree trimming, removal of vegetation that impinges on clearance spaces, and some relocation or use of Aerial Bundled Conductor in areas of significance to reduce the impact of vegetation on outages.

It was noted that the latest vegetation management contract has recently been placed, and there is a strong expectation that this will lead to a significant improvement in vegetation management in the Darwin Network.

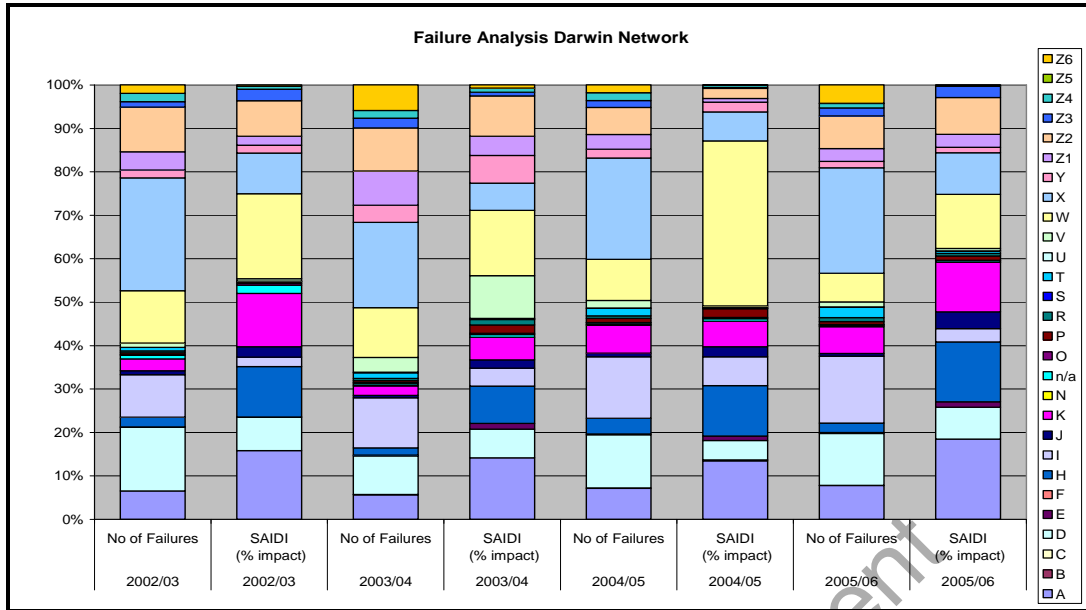
Figure 55: Causes of Outages in PWC Darwin Network

The largest cause of failure in the Darwin Network is load shedding shown in pale yellow. The second largest cause is equipment failure, which is seen clearly in Figure 55, Figure 56 and Figure 57. The purple coloured bar in the graph on Figure 55, shows an interesting fact. The number of equipment failures as a percentage is not as high as is the impact on SAIDI. This is similar to the animals and birds category “K” shown in bright pink. In general equipment damage and bird and animal strikes usually cause longer duration outages in order to repair and replace damaged assets. Another large impact was shown in blue “x” no cause found, and at over 25% of all incidents as a percentage of total incidents it is too high. More work needs to be carried out to determine the root cause of failures in the network. This will enable effective maintenance and replacement strategies to be developed.

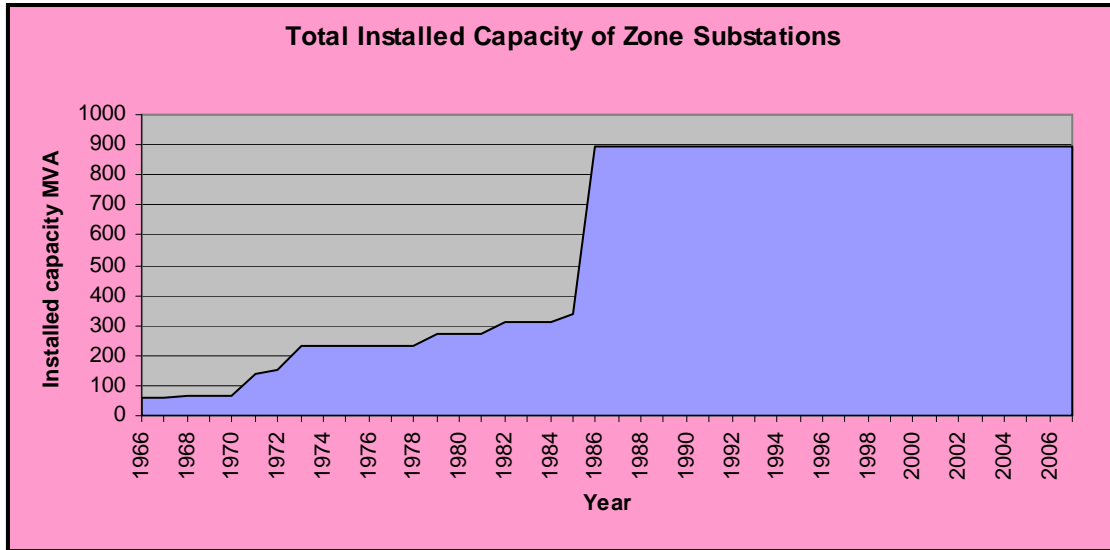
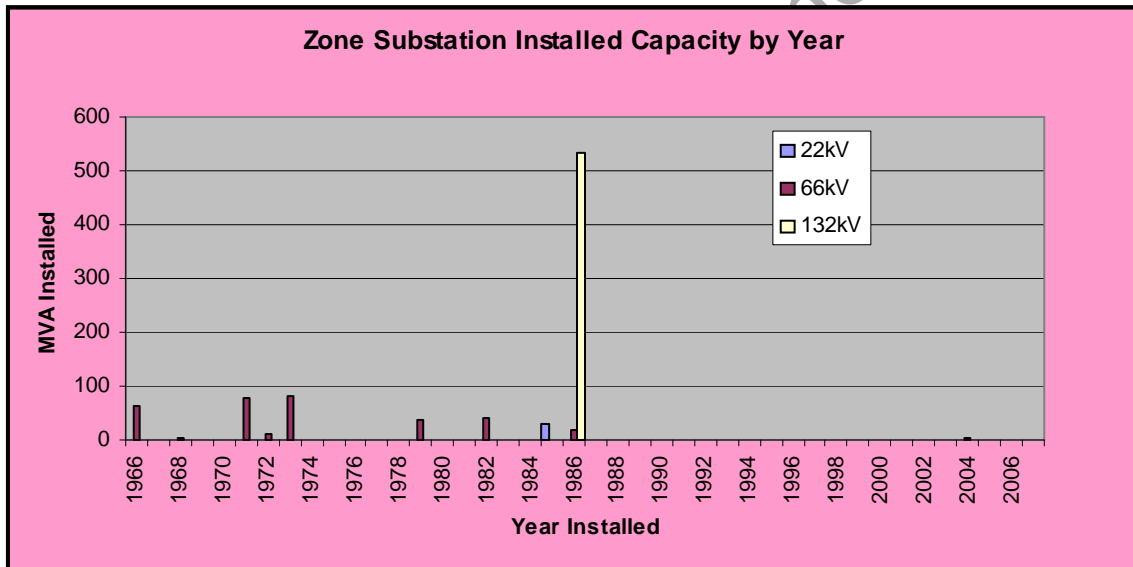
The age profile of zone substation transformers shown in Figure 59 and Figure 60 indicates that the earliest assets installed have reached the end of their economic lives, and will need replacement in the next 5 years.

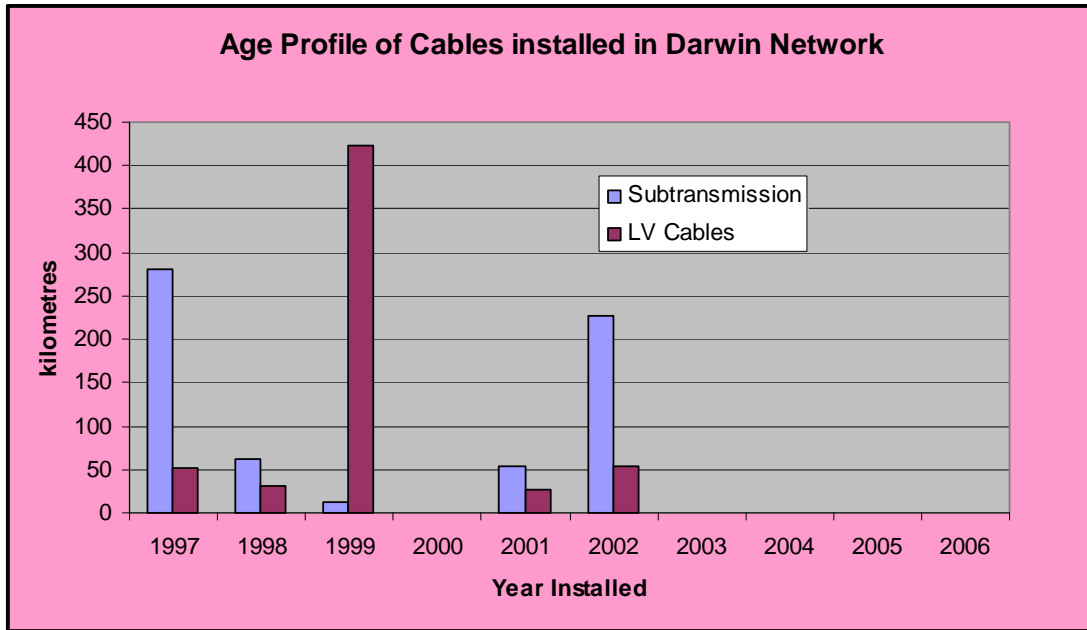
Figure 62: Age Profile of sub-transmission and LV Cables

The cable age profile shown in Figure 62 appears to be fine. However there are a significant number of cables not included in the available data due to unknown age. It is estimated that at least 15% of all the cables installed in the network was installed pre cyclone Tracey, in the period 1960 to 1971. These cables are likely to have reached the end of their useful lives and will need to be replaced in the next 5 years.

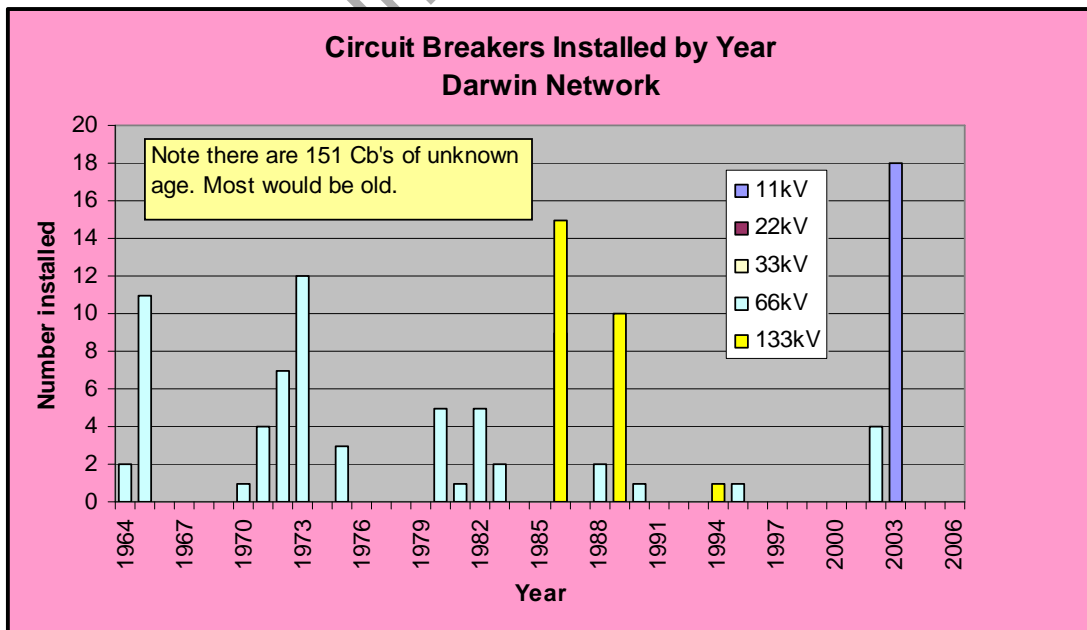
Figure 63: Age Profile of Circuit Breakers Installed in Darwin Network

The age profile of Circuit breakers is shown in Figure 63. There are 13 66kV Circuit Breakers that are over 40 years old. In itself this is not a problem, but the lack of adequate maintenance over the past 10 years would lead me to believe that these CB's will need to be replaced or refurbished in the near future. Availability of spares will be a real issue for refurbishment, and as such it is likely that at least 5 to 12 CB's will need to be replaced within the next 5-10 years.

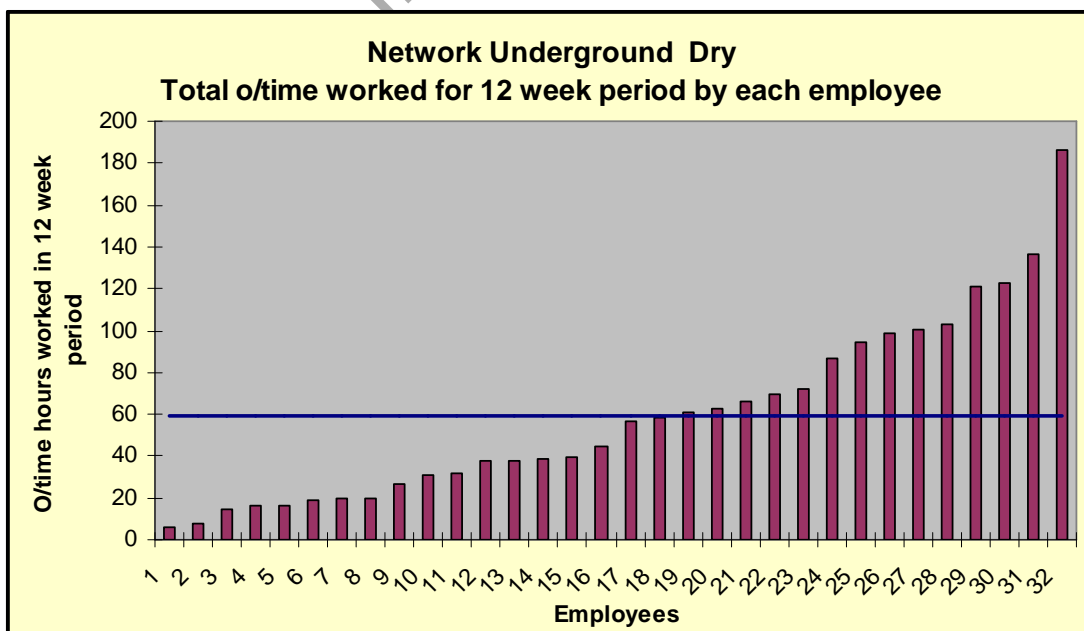
Figure 100: Total overtime worked by each employee in Underground Networks in 12 week Period Dry Season

An individual worked an astoundingly high level of overtime over a 12-week period in the dry season at 186.5 hours as shown in Figure 100. The average worked by the 32 employees that worked overtime was also a high 59.5 hours, which averages 5 hours per week. There were 7 out of the total of 32 that did around 100 hours plus in the 12-week period.

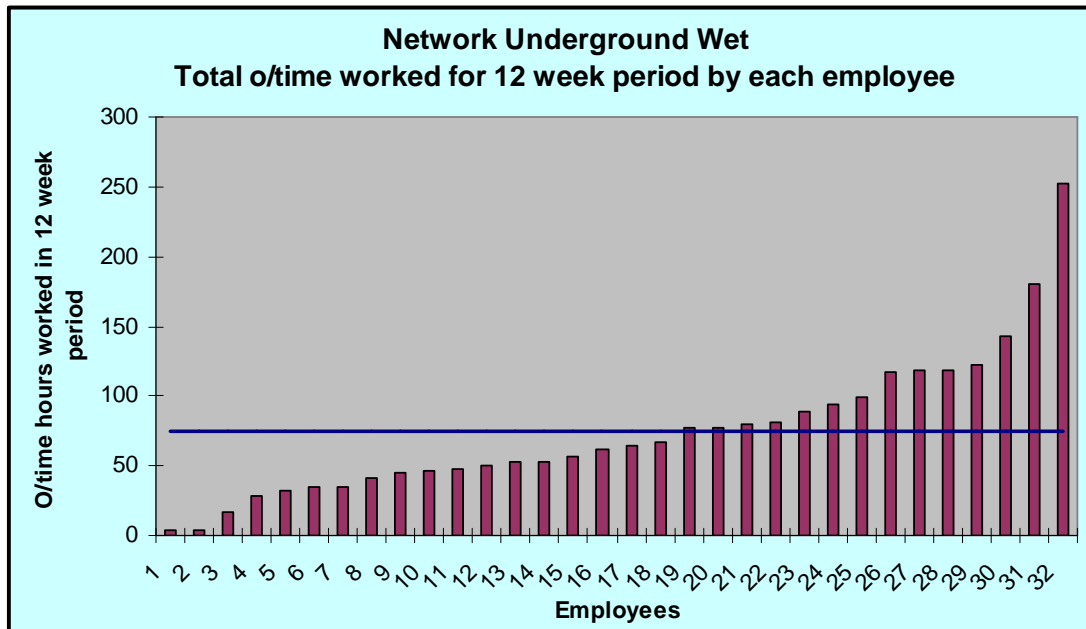
Figure 101: Total overtime worked by each employee in Underground Networks in 12 week period Wet Season

There was an even higher 252.25 hours worked by one employee over the 12 week period in the wet season, Figure 101, and the average was a high 74.7 hours which equates to 6 hours per week for each employee. Not surprisingly given the above there was a high individual overtime workload in a fortnight as shown in Figure 102.

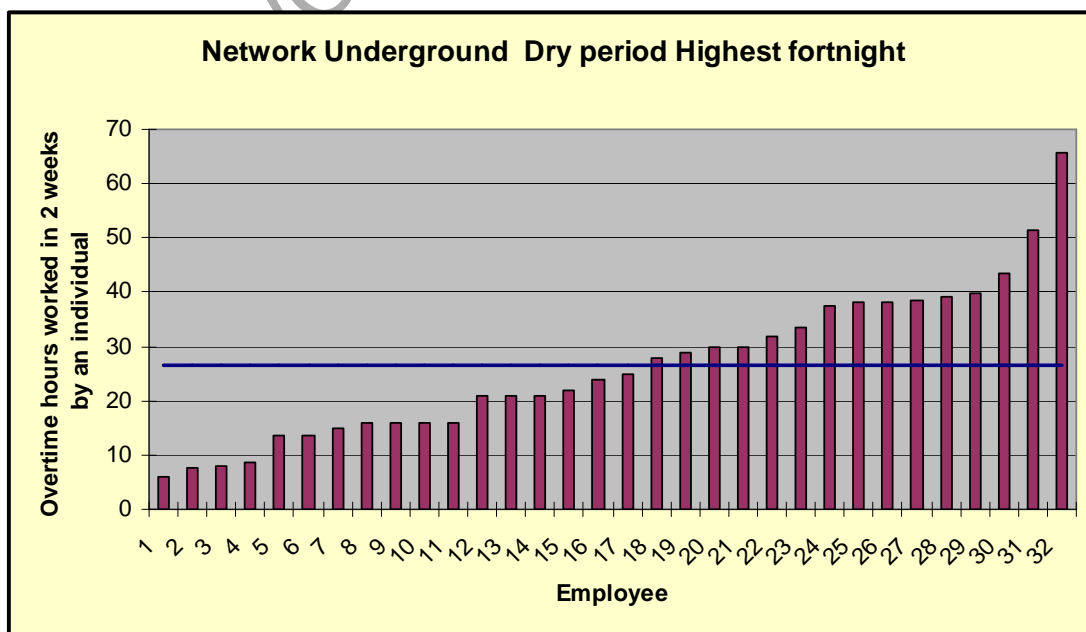
Figure 102: Individual employee highest fortnight of overtime worked in Dry Season

The highest fortnightly overtime worked by an individual was 65.75 hours and the average was 26.4 hours. This is again excessive, and would lead to problems if that workload were carried out for a prolonged period. The average of 13 hours per week is not excessive.

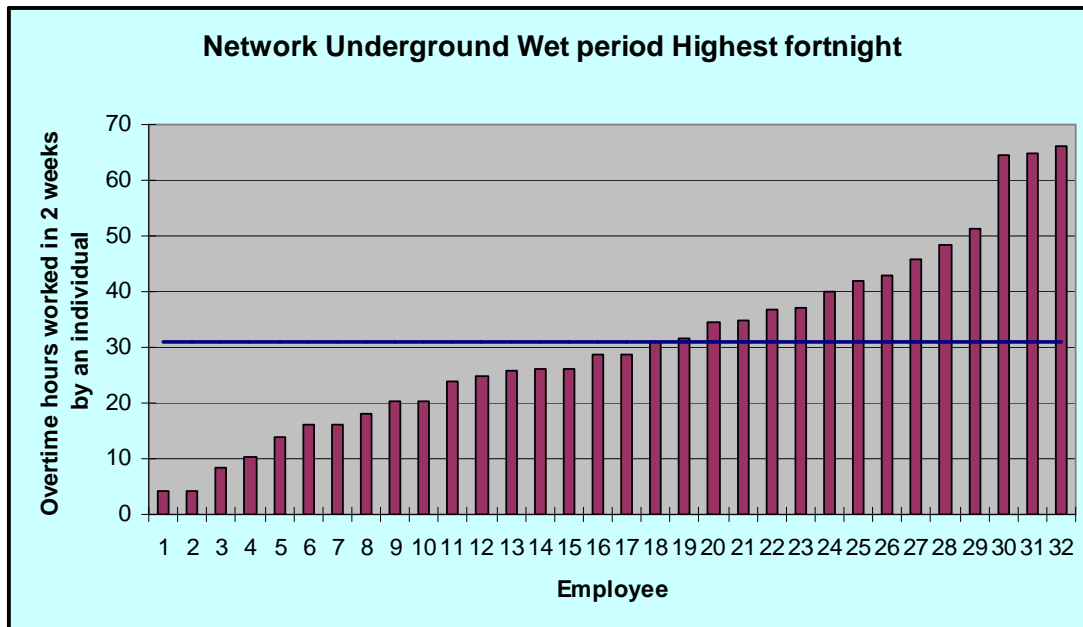
Figure 103: Individual employee highest fortnight of overtime worked in Wet Season

There were three employees at the highest individual workload in a fortnight between 64.5 and 66.25 hours as shown in Figure 103. The average for the highest fortnight for all 32 employees that worked overtime was 30.9 hours, which is a little high indicating that almost all of the staff that work overtime put in a lot of overtime in at least one fortnight over the wet season.

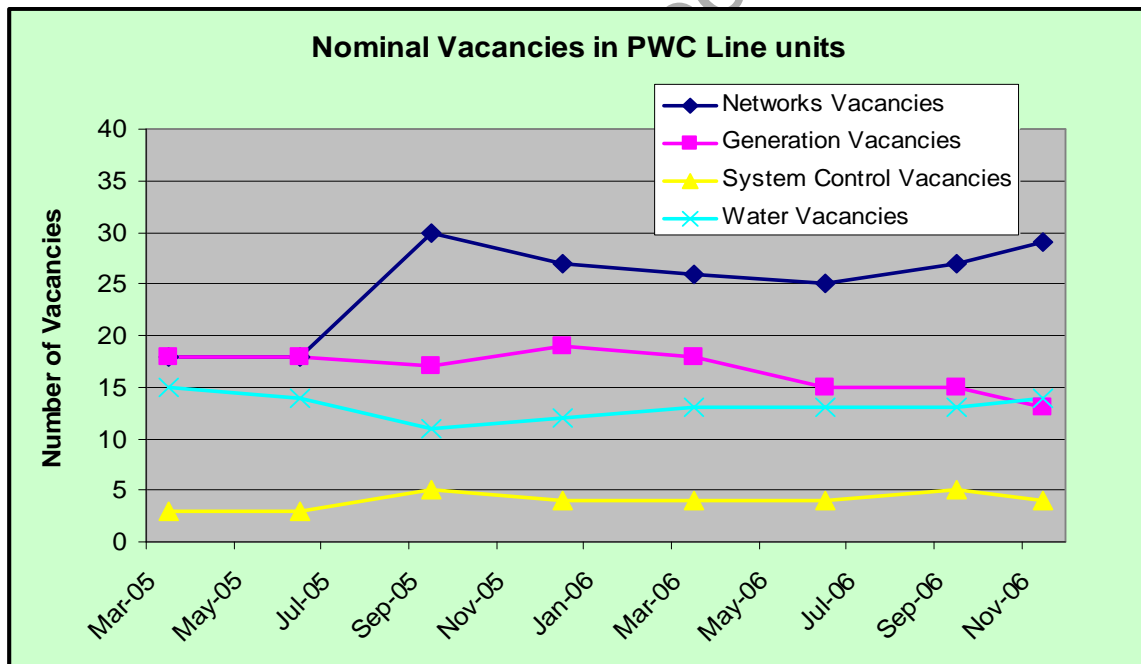
Figure 104: Nominal Vacancies in PWC Line Units 2005/6

The vacancies in each of the line units in PWC are depicted in Figure 104. There are in increasing number of vacancies in the networks area, partly due to wage pressure and strong recruitment from the other states in Australia. There has been a fairly constant level of vacancies in the Generation, system control and Water business units. This is of particular concern in that these 3 units have a lower number of staff in their business units and as such vacancies lead to significant impact on the ability to get the critical work done.

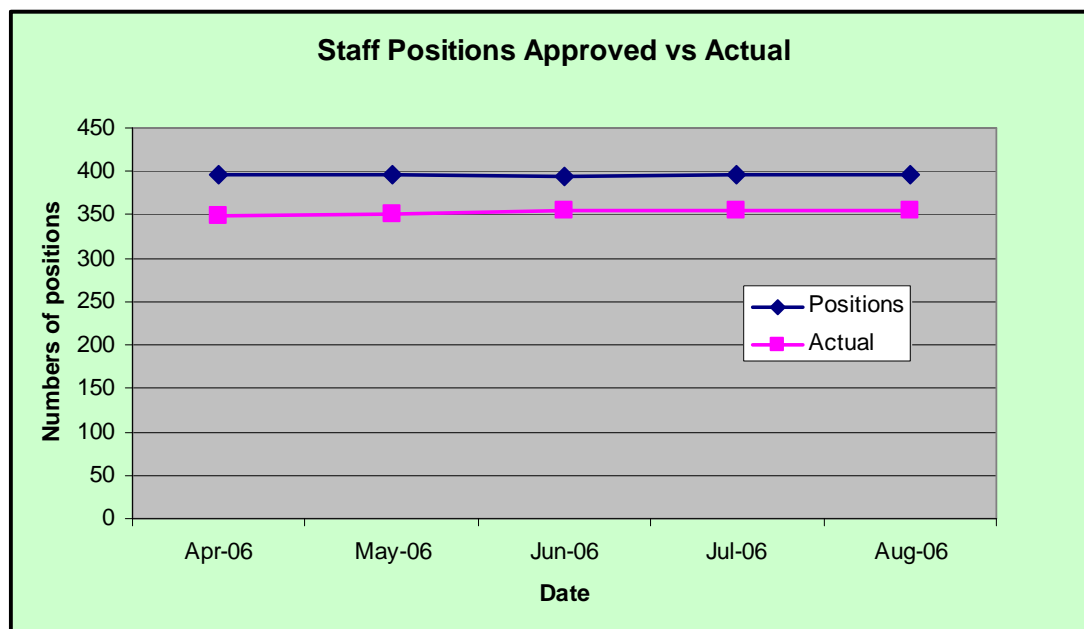
Figure 105: Positions vacant compared to approved positions Line Units 2006

Figure 105 shows the total number of positions in both approved and occupied positions for the line business units. There is an almost constant gap between approved and filled positions, as there is in any organisation, however with the difficulty that is inherent in recruiting personnel to the Northern Territory, and with the now tight staff numbers it is essential to reduce the gap between vacancies and filled positions to less than 5%.

and water at 8%, however for the smaller business units, water and generation the actual impact of vacancies is far greater and means in some cases that essential work cannot be carried out. It is recommended that PWC should actively over-recruit to redress this staff shortage, by carrying a number of supernumeries positions that can be transferred to establishment positions on the inevitable turnover of staff.
